**FINAL REPORT
AUGUST 2006**

REPORT NO. 06-03

**40"x44" METAL PALLET WITH METAL
ADAPTERS WITH PA125 METAL BOXES,
MIL-STD-1660 FIRST ARTICLE TESTS**

**DEFENSE AMMUNITION CENTER
VALIDATION ENGINEERING DIVISION
MCALESTER, OKLAHOMA 74501-9053**

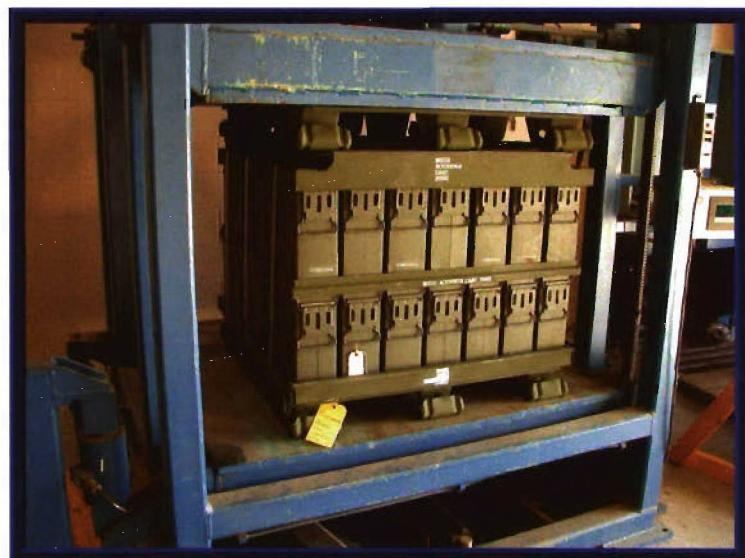
Photo 6. Test Setup for Compression Testing.

1. COMPRESSION TEST. Test Unit #1 was compressed with a load force of **12,800** pounds for 60 minutes on 11 July 2006. There was no damage noted to the test unit as a result of this test. See Photo 6 below for a typical picture of the test unit in the compression tester.

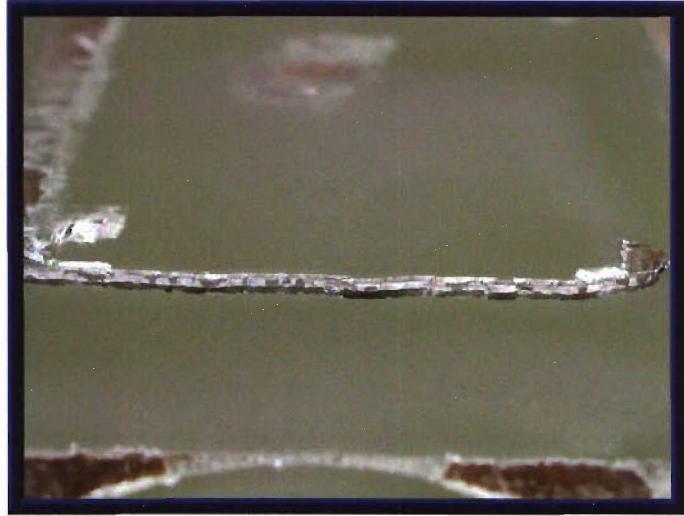
Photo 14. Damage Noted During Disassembly Test.

7. DISASSEMBLY TEST. During the disassembly of Test Unit #3 it was noted that the middle posts had broken through the top of the deck just as it had for Test Unit #2. See Photo 14 for the damage noted. No significant damage was noted from this test.
